## **5.4 BUILDING INNOVATIONS**

### **5.4.1 The Need for Innovations**

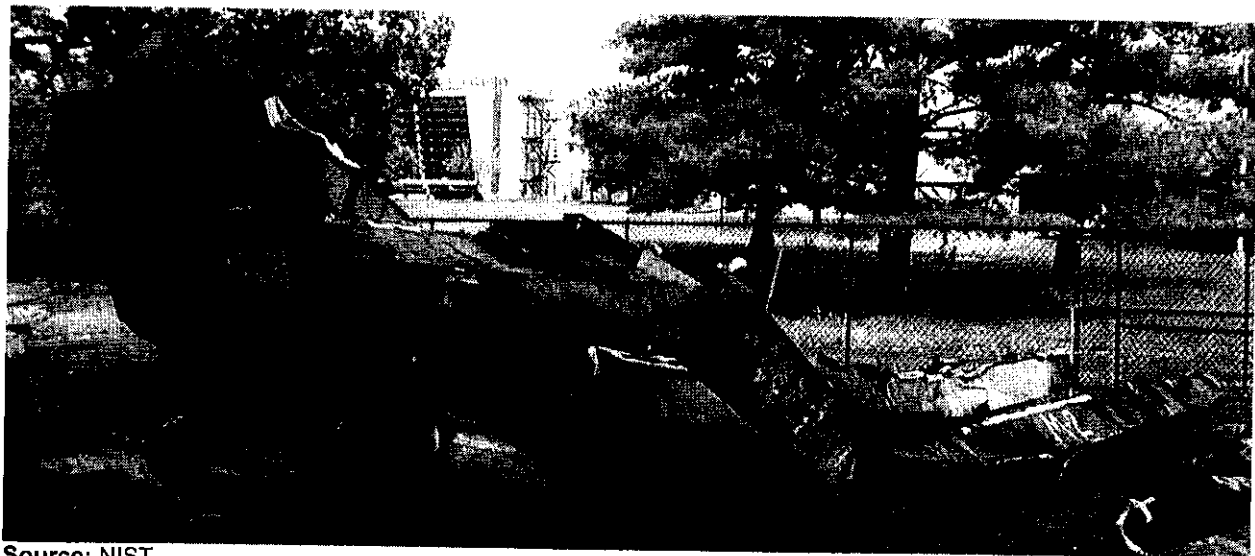
**Figure 6–4. WTC 1 exterior panel hit by the fuselage of the aircraft.**

For two of the five exterior panels from the impact zone of WTC 1, the general shape and appearance of the recovered pieces matched photographs taken just before the building collapse. Thus, NIST was able to attribute the observed damage to the aircraft impact. NIST also made determinations regarding the connections between structural steel elements:

- There was no evidence to indicate that the joining method, weld materials, or welding procedures were inadequate. Fractures of the columns in areas away from a welded joint were the result of stretching and thinning. Perimeter columns hit by the plane tended to fracture along heat-affected zones adjacent to welds.
